AGENDA Asset Mangement Committee 28th February 2022 DRAFT1	2
AGENDA ITEM 05a- Play Area quarterly reports	5
AGENDA ITEM 05c- Hornchurch Road Public open space, request for extra lighting	31
AGENDA ITEM 05d- Kestrel Court Play Area gate	32
AGENDA ITEM 06c- Request for permission to undertake metal detecting on the sports field	34
AGENDA ITEM 07a- Allotment report for public	35
AGENDA ITEM 07c- Allotment account to inform on any rent increases for 2022-23	36
AGENDA ITEM 07d - Request for shed and greenhouse on BSF 3	37
AGENDA ITEM 07e - Request for pond on the allotments	39
AGENDA ITEM 08d- Request to plant trees- wildflower area	44
AGENDA ITEM 09a- Price comparison for new defibrillator to be located in the Pathfinder Place development	47
AGENDA ITEM 10a- Pilot noticeboard	52
AGENDA ITEM 12- Bins purchased under Clerks delegated powers	56

MELKSHAM WITHOUT PARISH COUNCIL

Inspection Details

Type	Operational Inspection	Inspector	Kealan O'Loughlin		
Inspected	05/01/2022	Start Time:	11:47	End Time:	11:54
Weather Conditions	Sunny	No Visitors	0		
Site Accessible?	Yes	Report Complete?	Yes		
Report Date:	07/01/2022	App Inspection?	Yes v4.5.11 Android 11		
Customer Order No

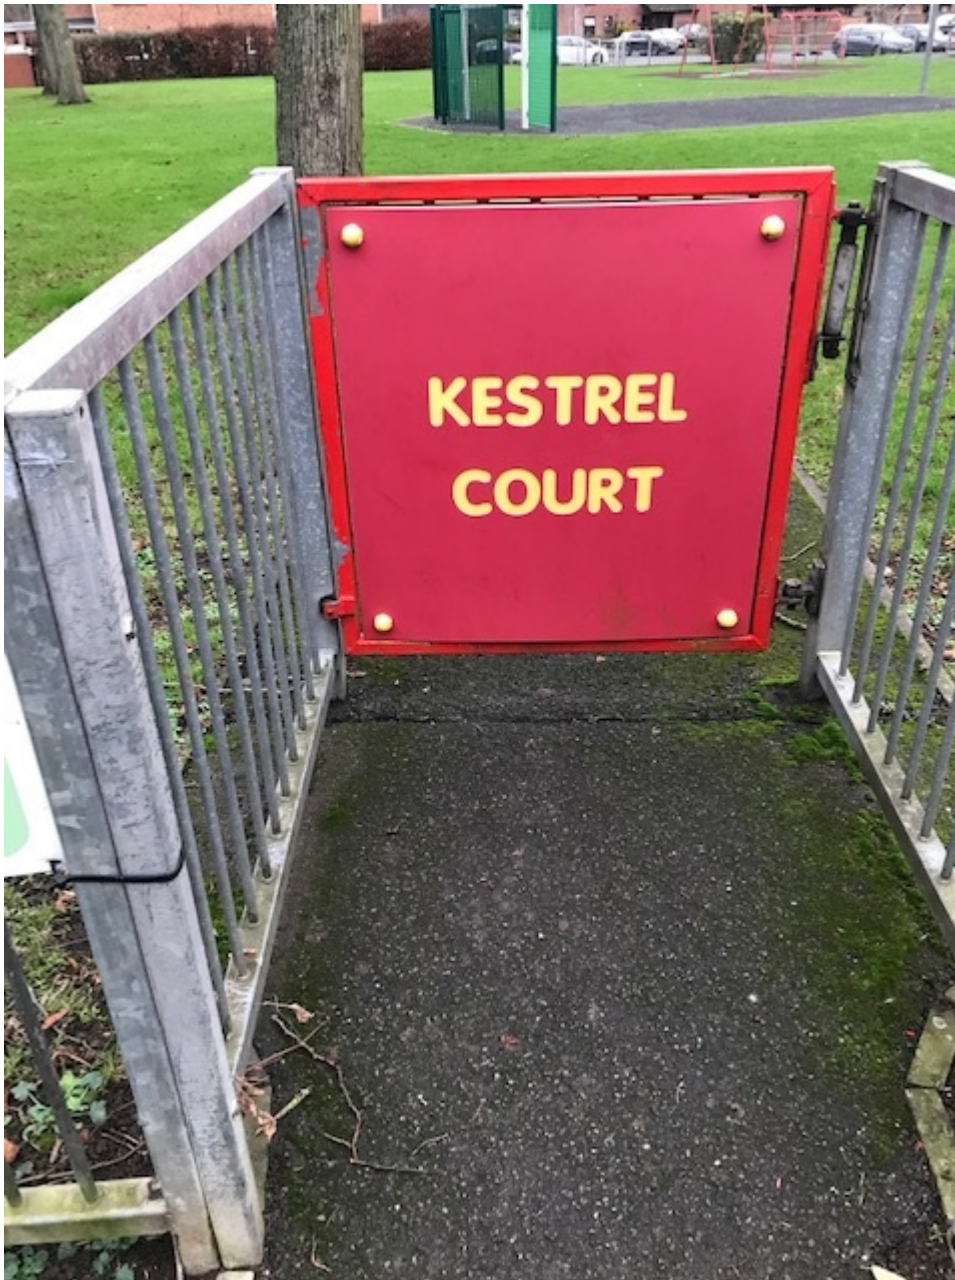
Hi. All equipment ok but complaints from residents about noise of closing gate. I agree with them. It's not the gate against the post banging that is the problem, but the red metal sheets attached to each side of the gate. These sheets are not on the other gate. They appear to have been forced fitted as both bow out, therefore allowing the sheets to bang against the grid of the gate.
